# Halton Holegate Parish Council

## Report and Investigations into Flooding in Halton Holegate in October 2023

**Version: Final**

**Issued: 14/12/2023**

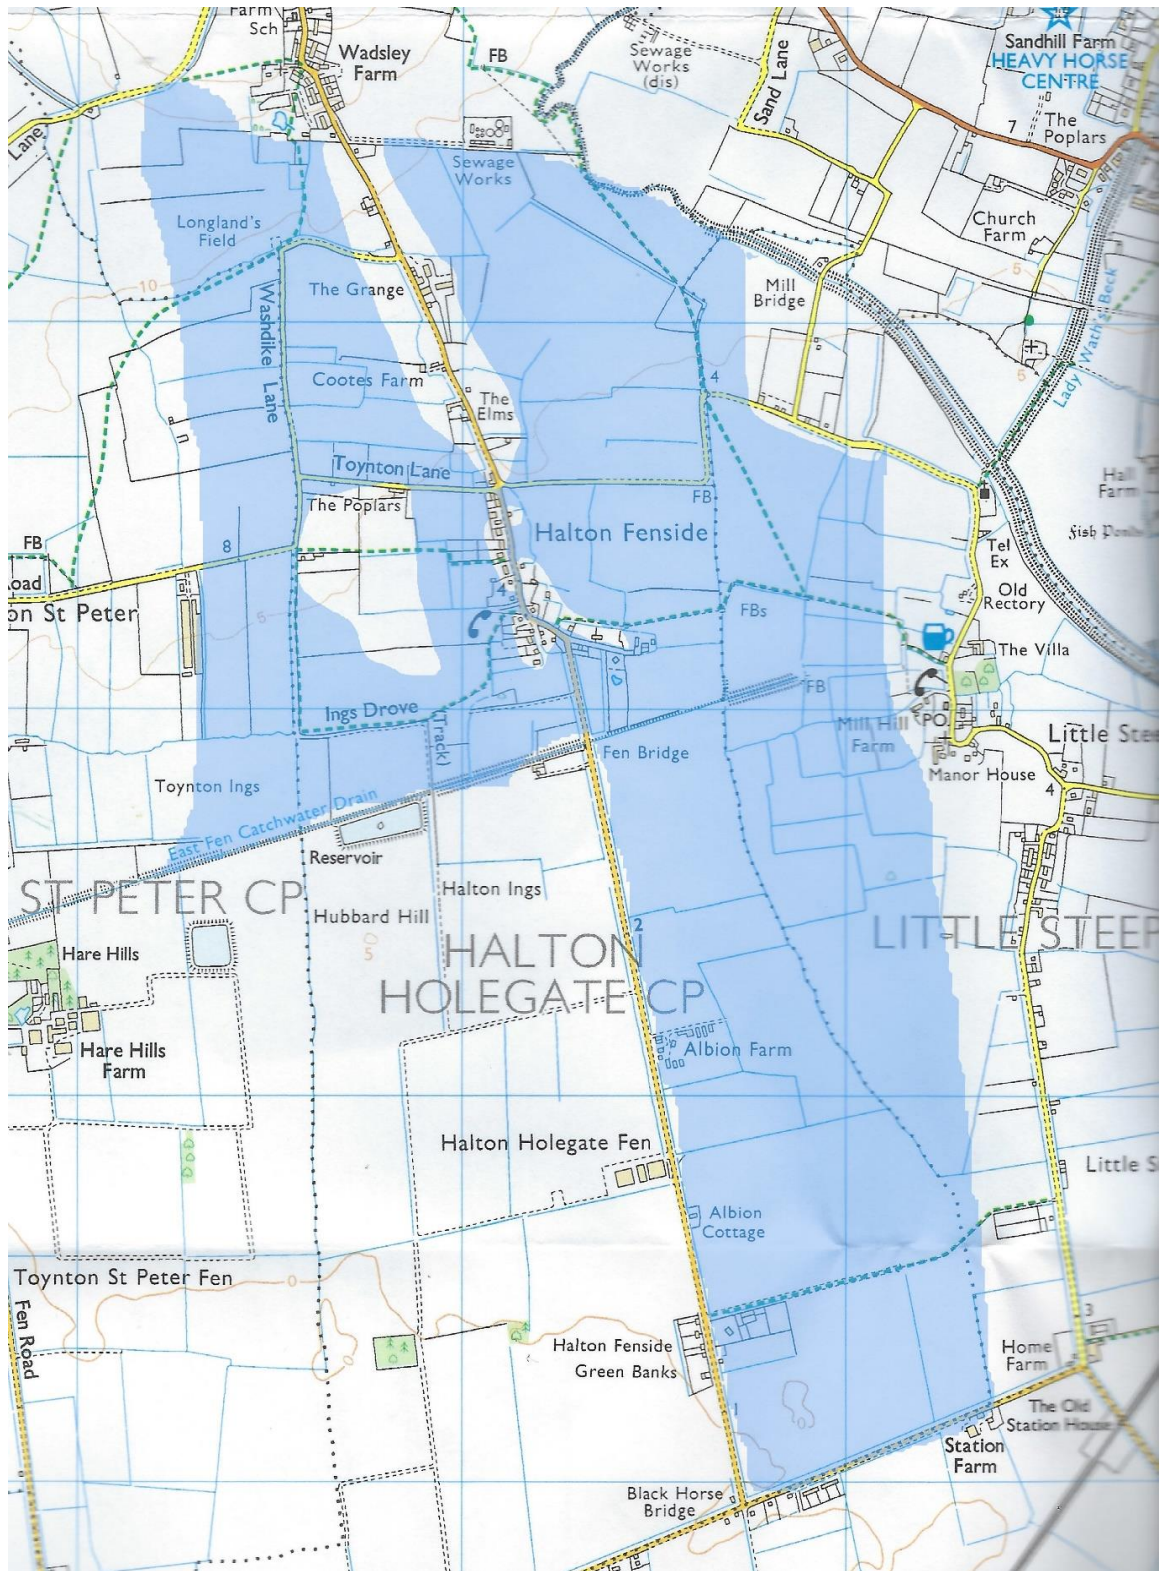
Map 3 – Flooded Areas

Map 3 below shows the resultant Flooded Areas and Appendix 2 photographs of the event.

As well as the properties flooded(detailed above) a significant area of farmland was flooded to depths of around 0.75m at its worst. This flood was contained from spreading further by Fen Road and Thorpe Bank Drain.

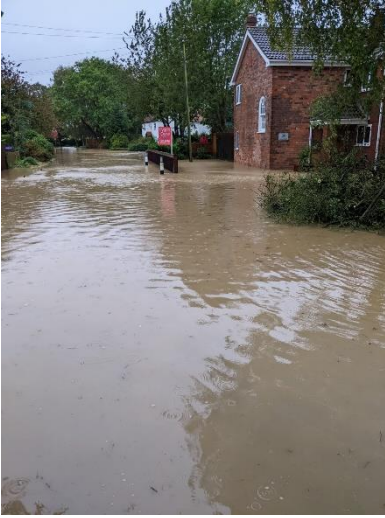
**Fen Road Halton Fenside**

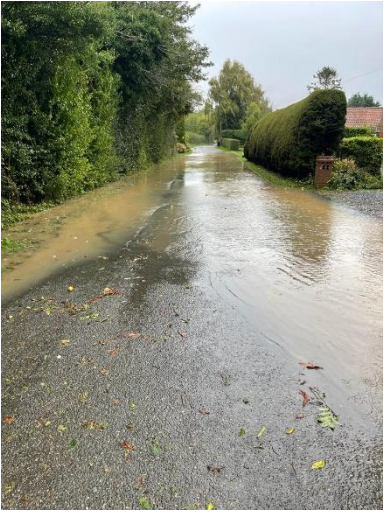
**Fen Road Halton Fenside**

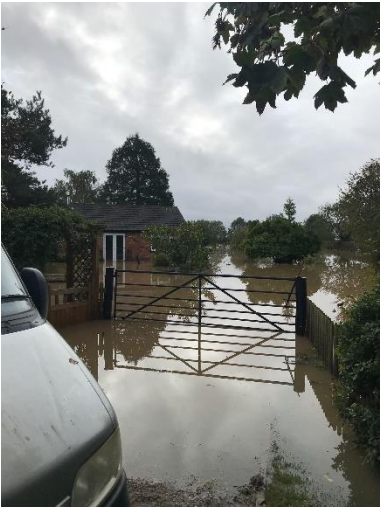
**Gardens Fen Road Halton Fenside**

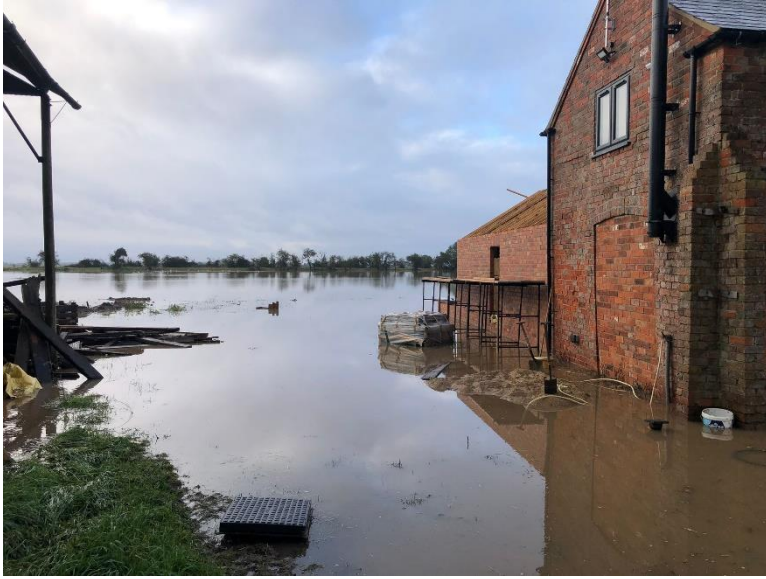
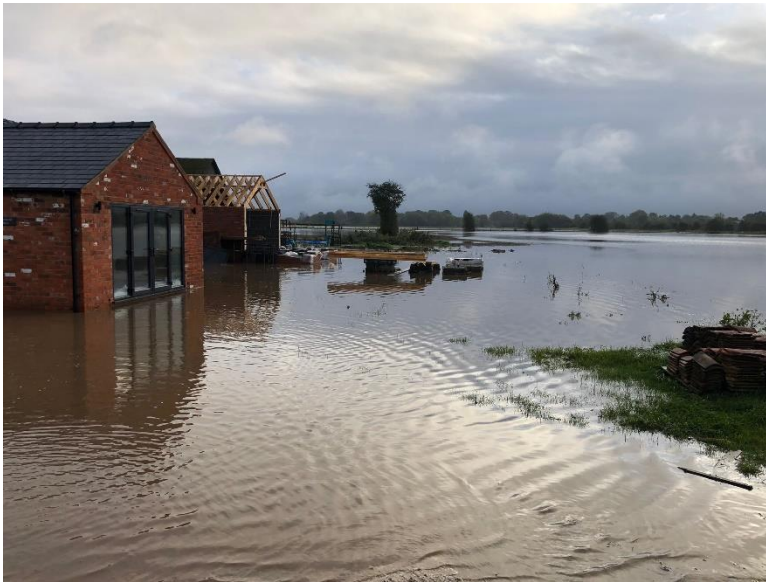
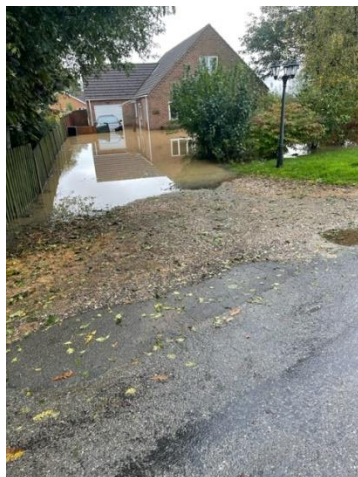
This over topping water also flowed across fields and entered the southeastern section of Fenside around Pinfold Lane. A further 7 properties suffered internal flooding from these two sources and a further two suffered flooding of outbuildings or integral garages, stables etc.

**Property and Land Flooding in Pinfold Lane, Halton Fenside**

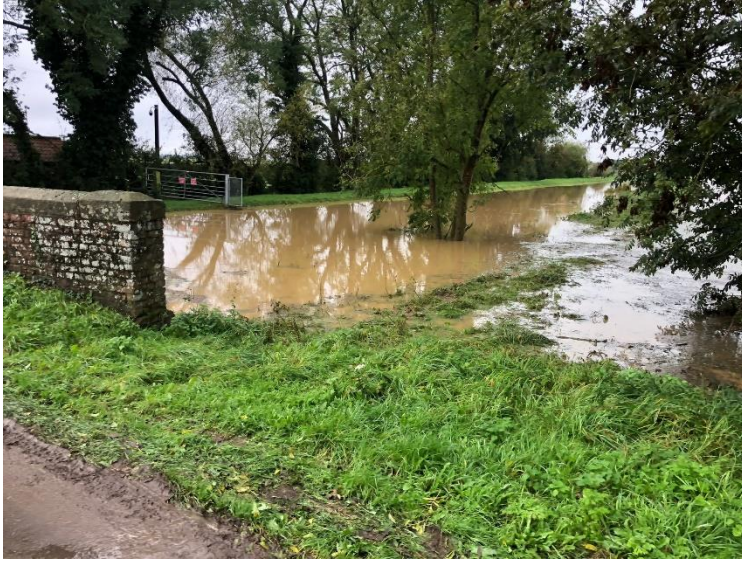
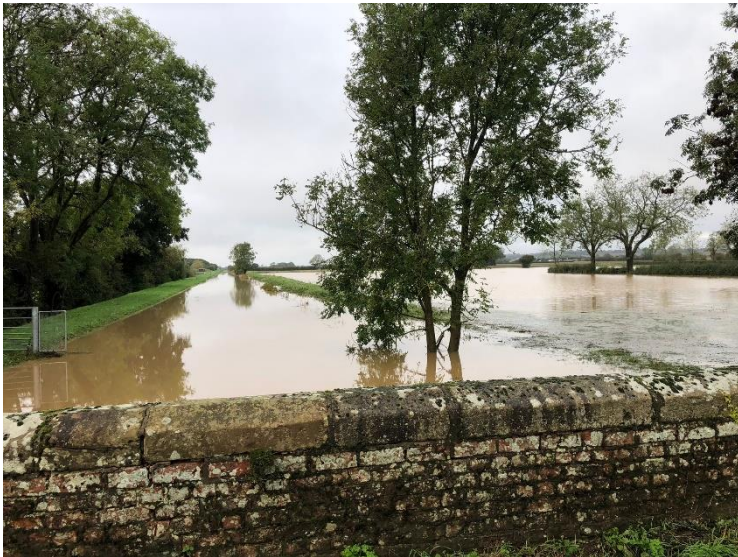
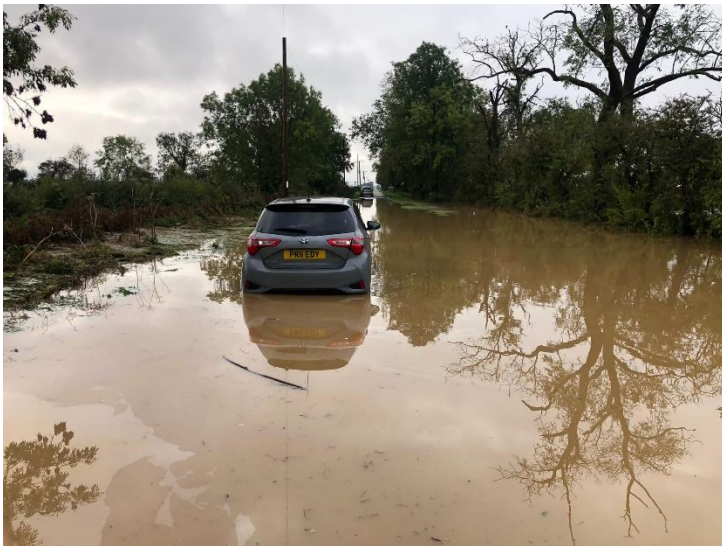
Later in the day of 19<sup>th</sup> October overtopping of both the east Fen Catchwater (at two locations) and the right bank of the River Steeping near the Spilsby Sewage Treatment Works just to the east of the village occurred. Exact timings are uncertain, but it is understood this continued for some hours (possibly more than 12 hours ) into Saturday 20<sup>th</sup> October.

**Overtopping of right bank of East Fen Catchwater at Halton Fen Bridge**

## **2 Bank Raising of Low Spots in the Banks of the East Fen Catchwater and River Steeping.**

The Parish Council also believe that there are potentially large volumes of silt that has accumulated in the East Fen Catchwater which has two detrimental impacts – Firstly by resulting in higher water levels year-round and also as the high silt levels encourages prolific weed growth that impedes conveyance of flows. Removal of weeds mitigates these adverse impacts thus speeding up recovery. A second request after removal of all silt deposits and weed growth is that water levels should be lowered in advance of a predicted storm event to allow for greater capacity for flood water storage during the initial phases of an event.

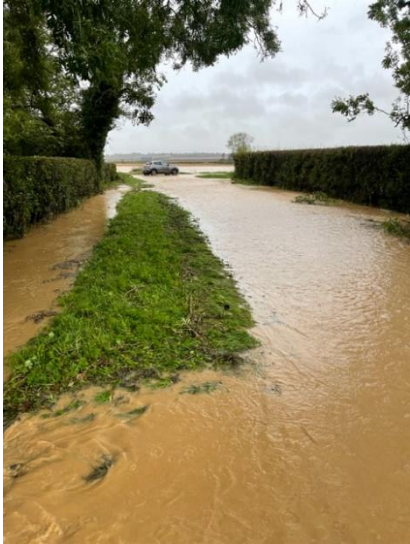
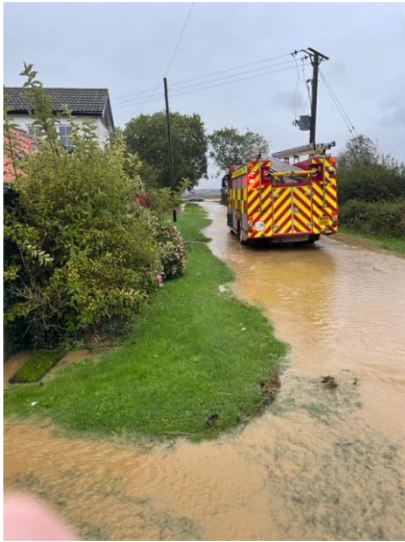
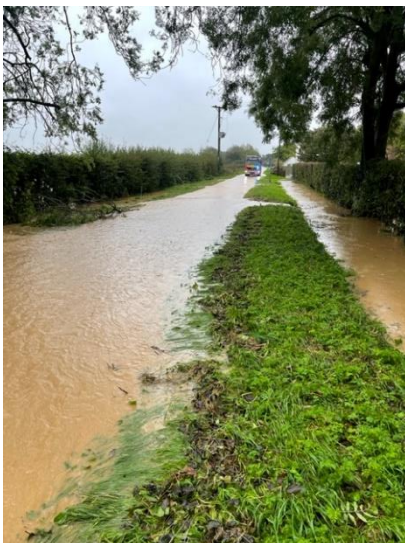
The under capacity of the watercourse was also intensified by the relatively small size of the Road Culvert where it passes under Toynton Lane. During the event significant head loss was observed at the culvert which raised water levels even higher local to the culvert and thus increased the amount of overland water flows towards the Fenside area.

**Toynton Lane acting as a flood route Saturday 20<sup>th</sup> October.**

It is clear to Residents and the PC that this watercourse is incapable of passing these unattenuated flows and needs adoption by and improvement by the Joint FRMAs to make it fit for purpose. This to include upsizing of the Toynton Lane Road Culvert and the construction of a flood protection barrier bank on the east side of the watercourse to prevent water escaping and flowing overland towards the Fenside area. These measures are needed in addition to the construction of significant new attenuation areas, to be built on the outskirts of Spilsby to cater for run-off from all the recent developments over the last 20 Years or so and those proposed and the planned major development to the East of the Town. The PC considers that the failure to build such attenuation areas when the existing developments took place to be a major flaw within the Planning System and of the Joint FRMAs duty to protect third parties from increased flood risk.

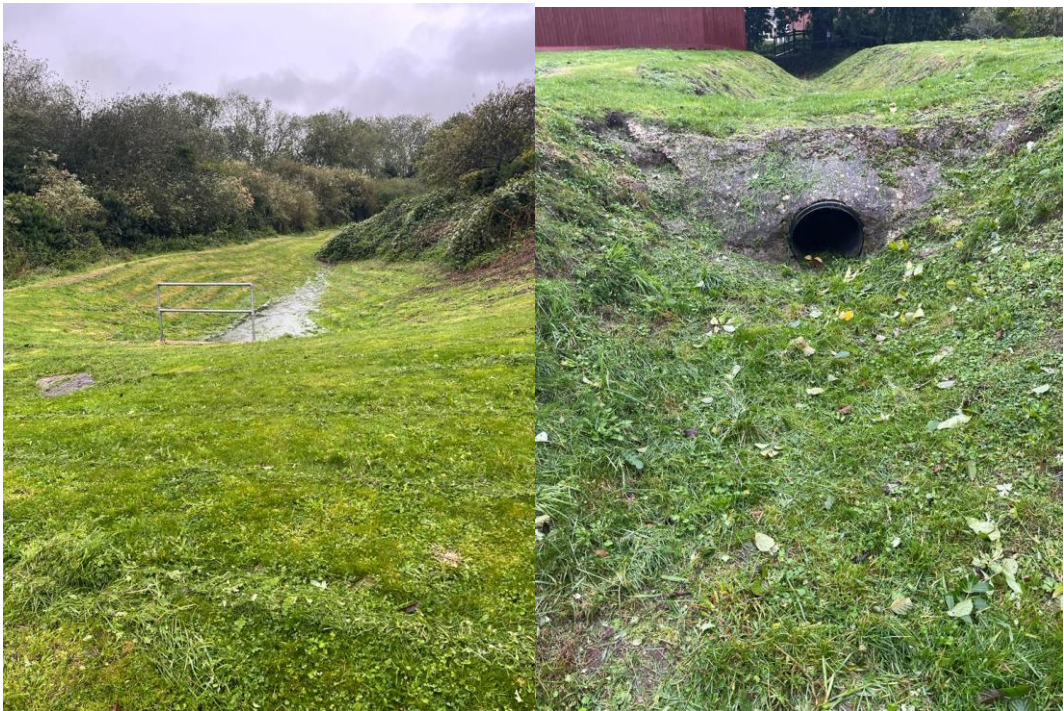
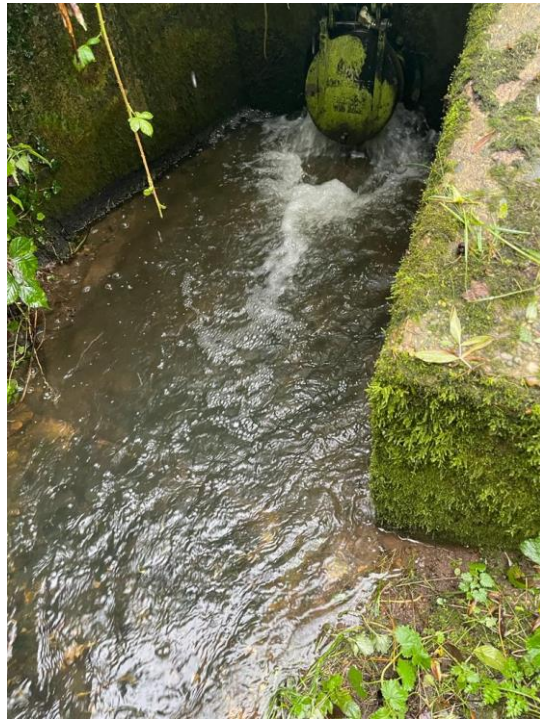
There is anecdotal evidence that one such small attenuation area exists to serve the Lady Jane Franklin Drive area but when visited by a PC member during the flood was observed to be dry.

**Flood Attenuation Area – Lady Franklin Drive Friday 19<sup>th</sup> October 2023  
Showing Dry storage Area and unattenuated discharge.**

This Council calls for full consultation and participation with those who will influence and consent the proposed major development when determining the application.

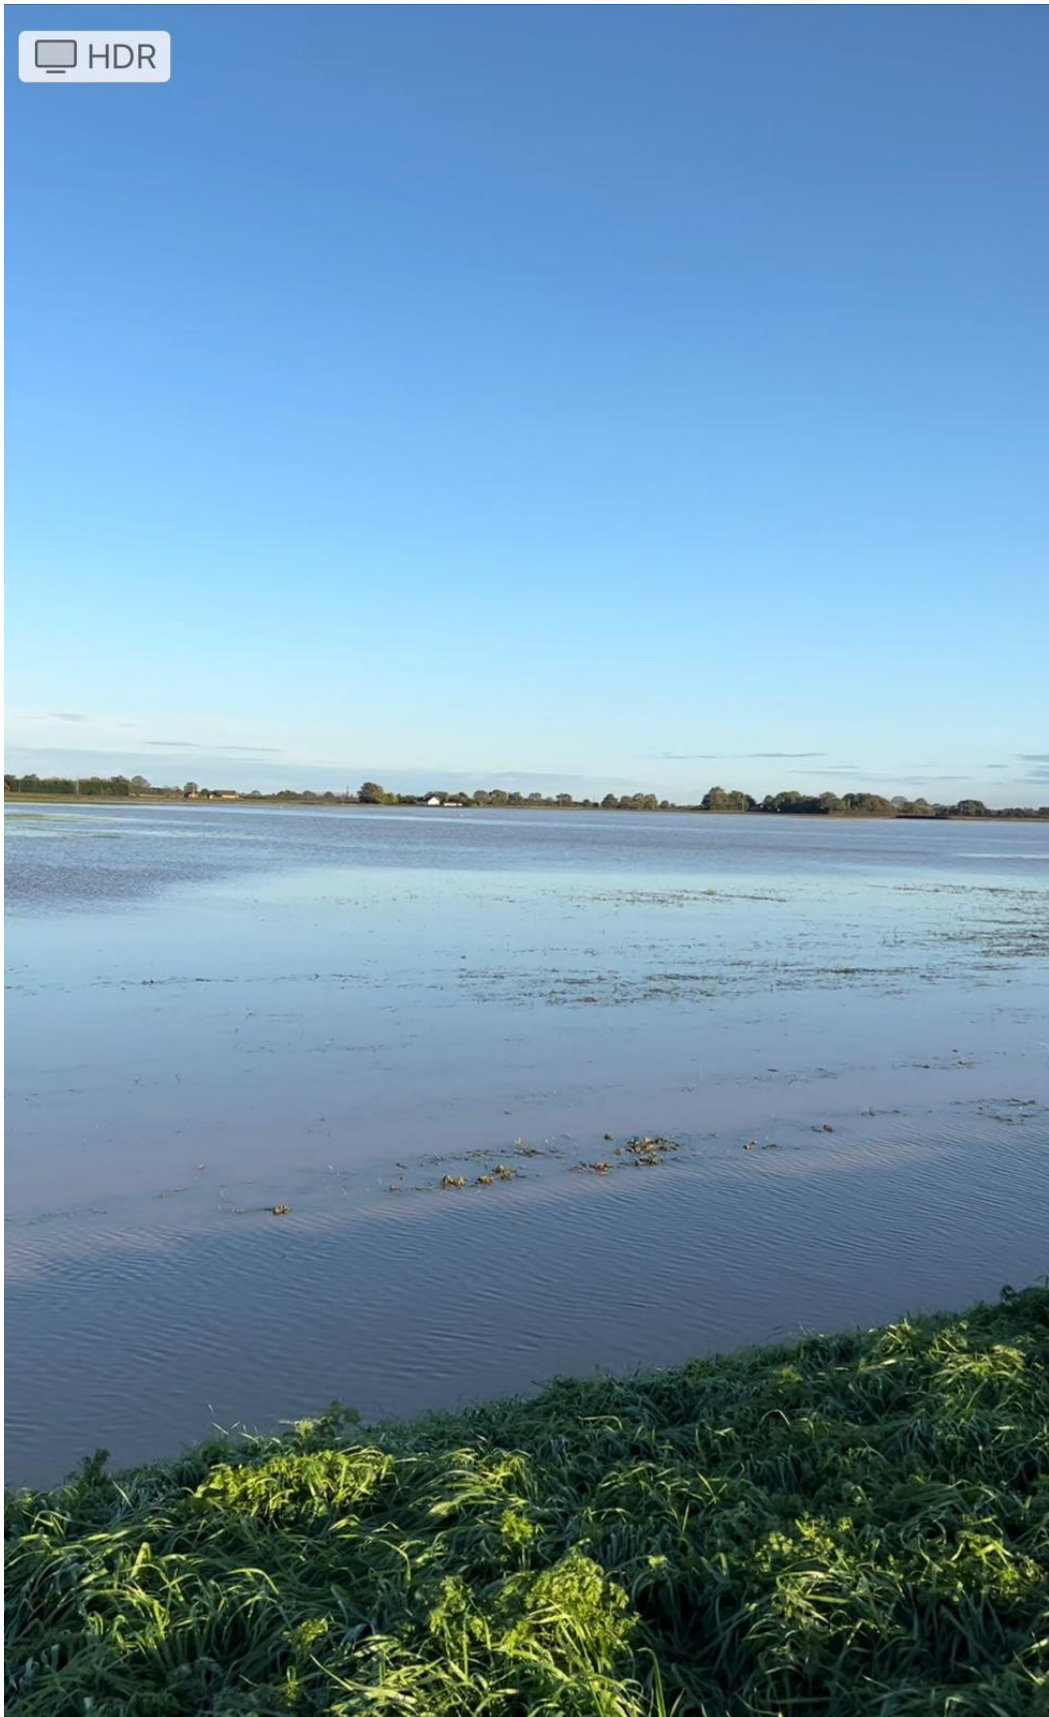
Halton Fen was inundated for the first time in living memory, and this was as a direct result of overtopping of both the River Steeping and the East Fen Catchwater. The water after escaping the Main Rivers as well as flowing overland towards Fenside also followed internal drainage systems finally finding its way into the area south of Pinfold Lane and into Halton Fen. Flood flows of this nature had not previously been witnessed within the Parish and certainly not on this scale.

**General View of Flooding of Land and Isolated Properties in Halton Fen**
